AUTOMOTIVE EQUIPMENT ACCIDENT RECONSTRUCTION & TESTING

ESI was asked to perform analysis regarding a vehicle support collapse. While a faulty jack stand was alleged, ESI investigated an alternate hypothesis in which misuse of a pump jack produced the movements and witness marks consistent with available evidence.

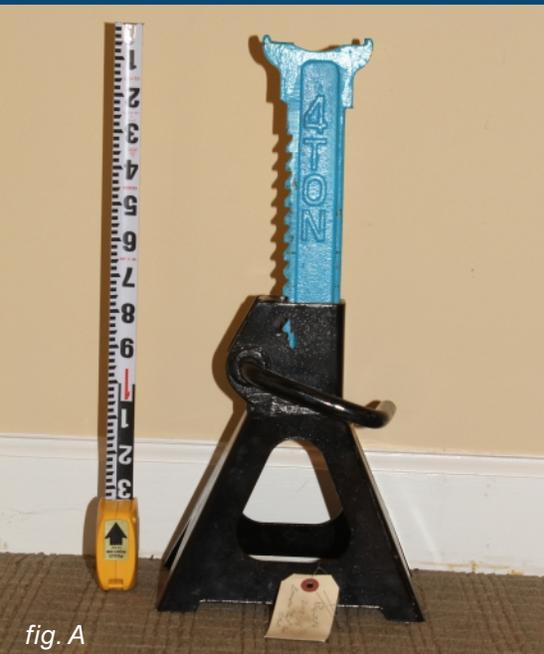
fig. A

A vehicle fell causing personal injury. Both ratcheting jack stands (fig. A) and a 3 ½ ton hydraulic service jack, or pump jack (fig. B) were found at the scene. Witnesses found jack stands tipped over near and beneath the vehicle, while the pump jack was found adjacent to the vehicle and missing its saddle cup. A saddle cup is a pump jack component used to grip a vehicle as it is raised and lowered. Immediately after the incident, and despite the missing saddle cup, the subject pump jack was successfully used for extrication, and the found jack stands were successfully used for vehicle stabilization.

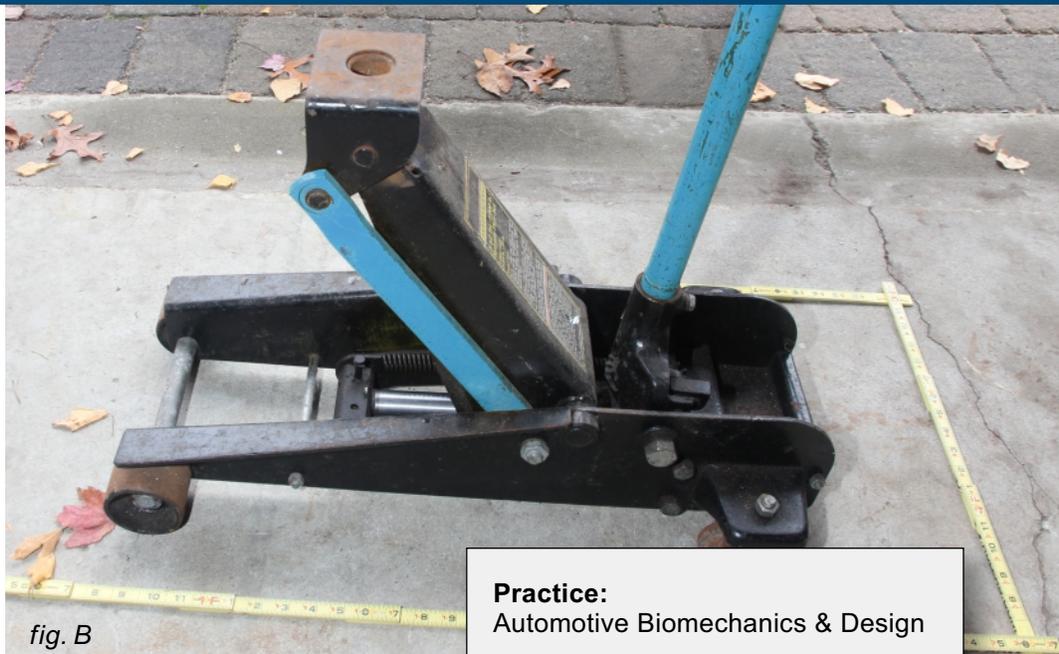
fig. B

The police found the right front wheel assembly removed from the hub and a socket wrench still attached to the vehicle's oil drain plug. The police report noted water condensation present on the bare metal of the pump jack upper lifting surface, at the location where the saddle cup was intended to be present.

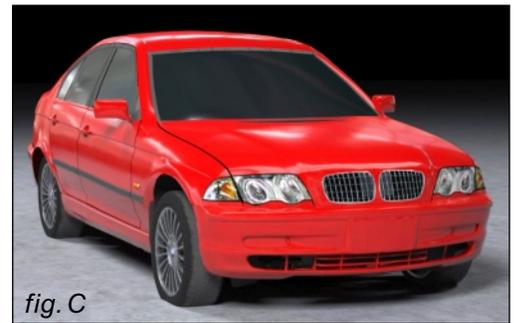
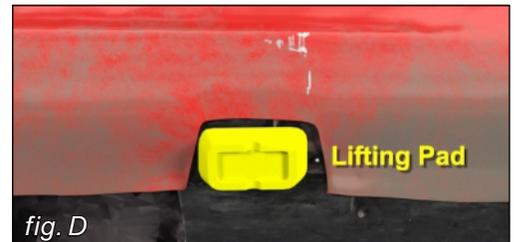
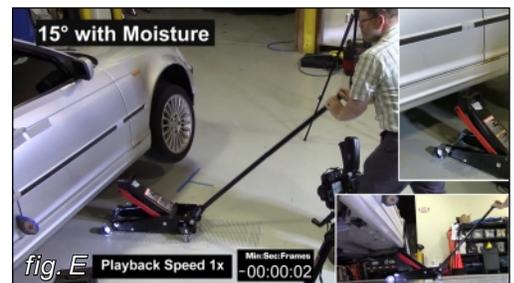
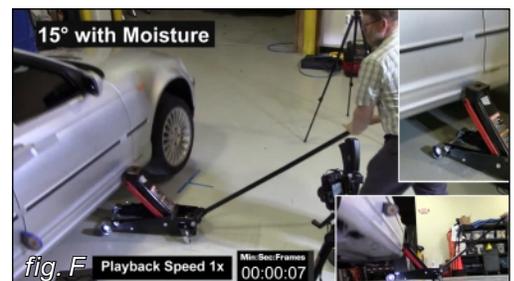
Analysis of the vehicle and key automotive components revealed an absence of witness marks supportive of the jack stand hypothesis (no indication of under-body contact where supports were alleged to have been). Contrastingly, significant witness marks supportive of the pump jack hypothesis were found, including deformation and scrape marks adjacent to the vehicle's right front lifting pad.

Finally, a series of physical tests were performed and recorded using exemplar equipment in order to demonstrate that the vehicle's molded plastic lifting pad, elevated by a pump jack, would rapidly slip out of contact with the pump jack's lifting surface due to plastic creep behavior. This effect caused ejection of the pump jack and the production of witness marks nearly identical to those observed on the subject vehicle. See figures E through H.

Based on physical evidence and testing, ESi concluded that the vehicle had been elevated and supported solely by the pump jack, and subsequently dropped, trapping the person beneath certain structural components. The support for this (pump jack) hypothesis was explained and presented through a series of images and animated videos developed from measurements of both subject and exemplar equipment, as well as test videos demonstrating substantially similar behavior to that hypothesized by ESi and the creation of appropriate component damage and scarring.
