METALLURGICAL EVALUATION FROM A REFEREE STANDPOINT

An investigation was performed to identify the root cause of “stardust” defects on a plated firearm, to determine their nature, location, and provide corrective actions.

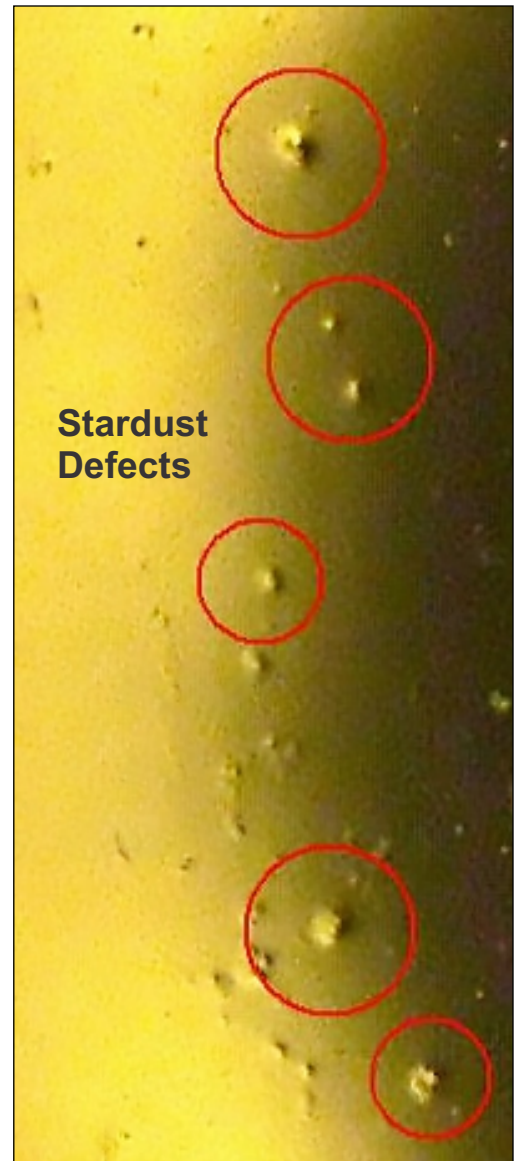
The CT scans coupled with the metallographic cross-sections identified the root cause of the “stardust” defects as originating in the plating, specifically in the copper plated layer, not the nickel-plated layer. The “stardust” was not originating from any die casting material defects (i.e. porosity, shrink, etc.). Inherent porosity was noted in the castings but was located much further beneath the surface and was not connected to the surface plating layers, where the defects were located.

To determine the exact nature of the copper layer defects, the metallurgical mounts were then examined by SEM/EDS (Scanning Electron Microscopy/Energy Dispersive X-ray Spectroscopy). This technique identified aluminum oxide particles trapped in the plated copper base layer. These particles caused the “stardust” appearance on the surface of the hardware, which was mirrored in the nickel plated layer. The fault of the defects was from the plating supplier. Filtration of the copper plating bath eliminated the problem.
