## STRUCTURAL EVALUATION AND REPAIR OF HURRICANE DAMAGE

A hurricane with wind forces in excess of 150 miles-per-hour made landfall on the US Gulf Coast near a commercial manufacturing facility causing significant damage to the area. Much of the area's infrastructure including power and communications was damaged by the storm and normal operations for the local area businesses was effectively stopped. This particular facility manufactured goods onsite for distribution to the region and the damages sustained to their production was a substantial strain to the owners.

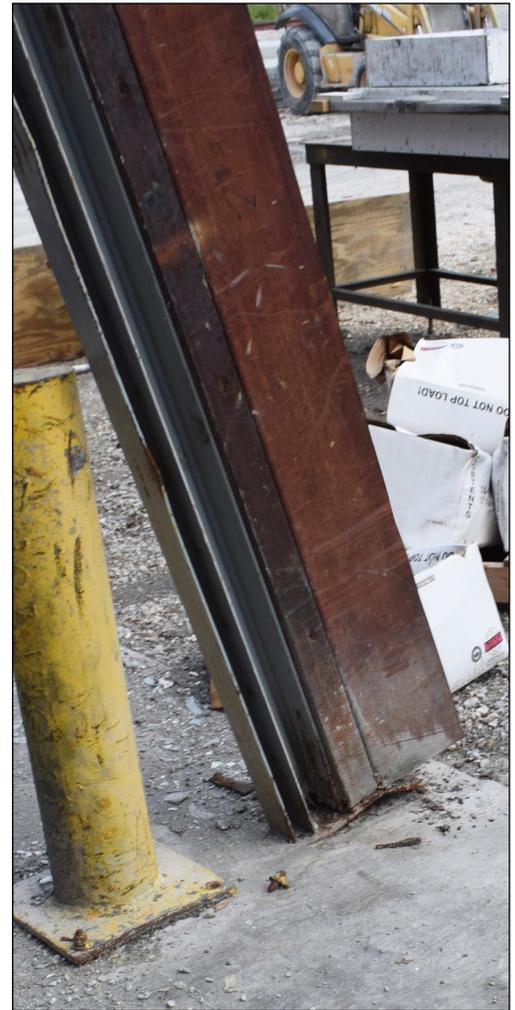
One of the technical issues that arose in this repair was the replacement of a steel portal frame. Metal buildings are widely used in commercial facilities because they are adaptable and relatively inexpensive. An issue in repairing these types of structures is when elements, in this case the portal frame, are purpose-built and not readily replaceable. Portal frames are made from cut plate and are tapered into light, but strong elements. Because the replacement frame will have to be tailor-made by the fabricator, the replacement design has to be done by a qualified engineer; otherwise, the entire structure can become deficient.

ESi inspected the 12-acre facility including several buildings of different complexity and extent of damage from the wind forces. Part of the resolution of the case involved ESi issuing repair/replace drawings sealed by a Professional Engineer and a report with a “take-off” list of repairs that the building consultants were then able to develop into a cost estimate for the damage.
