WHEN CLEANING MAKES A MESS

Using a combination of chemical and metallurgical principles, ESi determined that stainless steel kitchen components could be restored to their pristine state, following staining damage from acid exposure, eliminating need to purchase all new equipment.

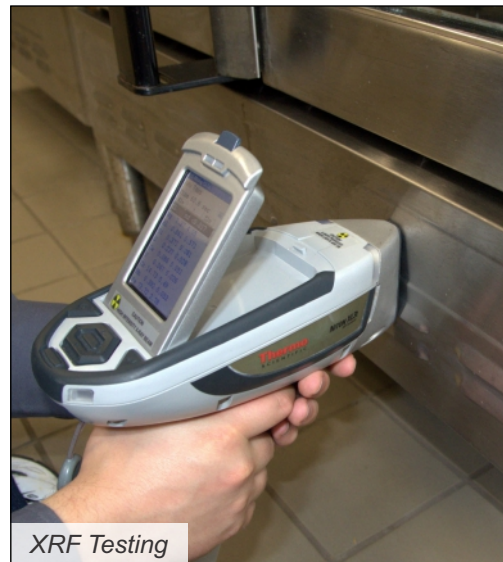
XRF Testing

ESI's investigation and analysis reached different conclusions from those of the renovation company that recommended complete replacement of stainless steel components. No evidence of pitting corrosion was found. XRF analyses revealed the presence of chlorine (from the muriatic acid) in regions of staining only. These results indicated that the claim of acid vapors having the propensity to cause further damage in areas that were not already visibly stained was highly unlikely, since the chlorine species was not present in unstained areas. Testing of pH determined that stainless steel surfaces were neutral, which further suggested that continued corrosion was unlikely in areas that were not already visibly stained.

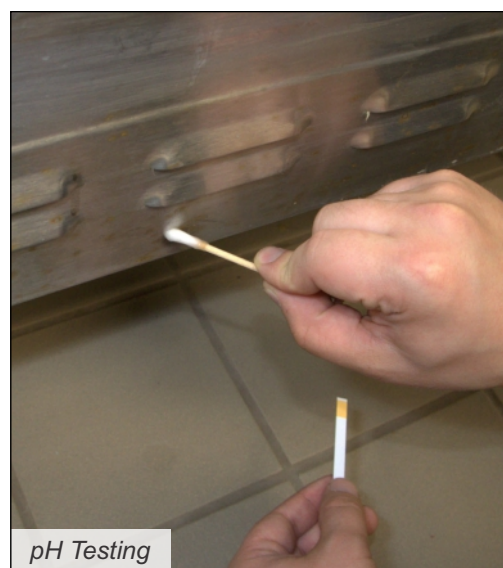
pH Testing

In order to characterize the damage to the stainless steel components, ESI performed a number of analysis activities. An on-site inspection was performed. A portable X-ray Fluorescence (XRF) analyzer was used to determine the specific stainless steel alloy of each component and identify chemical elements present in stained versus unstained areas. Litmus paper was also used to determine whether the surfaces were acidic, neutral, or basic.
