Railroad Paint System Failure Investigation

ESi investigated widespread paint bubbling and softness on 100 newly manufactured intermodal railcars, determining root cause through forensic analysis.

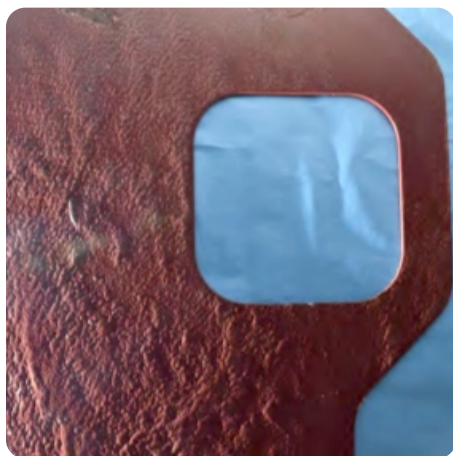
ESi's investigation determined that the paint failures resulted from formulation defects and quality control issues at the paint supplier, not manufacturing defects or application errors by the railcar manufacturer. Our analysis demonstrated that the railroad car manufacturer had properly prepared surfaces, applied paint to correct thickness specifications, and followed all prescribed procedures. The paint supplier's undisclosed formulation changes and use of inconsistent batch recipes caused incomplete curing, resulting in soft paint that developed internal bubbles over time.

Macroscopic overview of a railcar exterior panel with blistered coating. (Left)

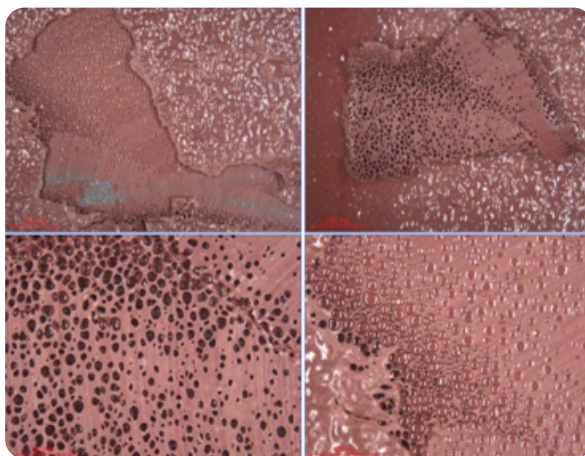
Microscopic images of blistered coating. Significant porosity was observed in bulk of the coating underlying the exterior skin layer. (Right)
