## PVC Plastic Threaded Fitting Failure Analysis

**Engineering analysis determined yacht sinking resulted from improper installation practices, not manufacturing defects.**

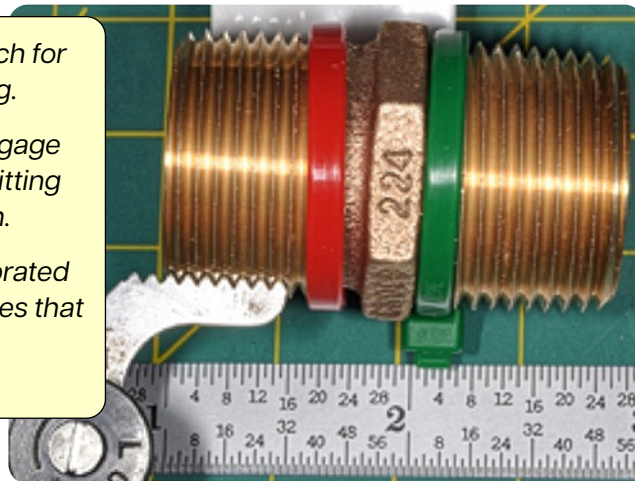
The team conducted precise thread measurements using calibrated pitch gages and industry-standard ring gages to verify compliance with ANSI/ASME B1.20.1 specifications for tapered pipe threads. Opposing experts claimed improper thread dimensions was the cause of the failure. However, ESI's SEM analysis showed that thread flats contain manufacturing burrs, making caliper measurements inherently inaccurate. This meticulous dimensional analysis was critical to evaluating the opposing experts' claims and ultimately determined that the

*The correct approach for assessment of fitting.*

*(Left) Use of a pitch gage demonstrates that fitting had 14 threads/ inch.*

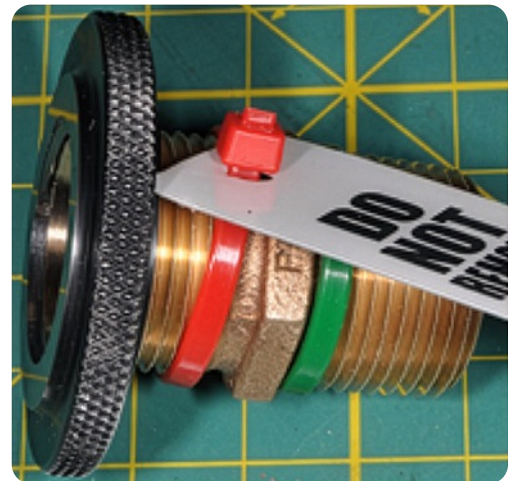
opposing experts had fundamentally misinterpreted ANSI B1.20.1 threading standards.

*(Right) Use of a calibrated L1 gage demonstrates that fitting met NPT specification.*
