Be Careful Walking the Dog: An Orthopedic Leg Brace Failure

ESi was engaged in a personal injury matter to study the root cause of an orthotic leg brace failure.

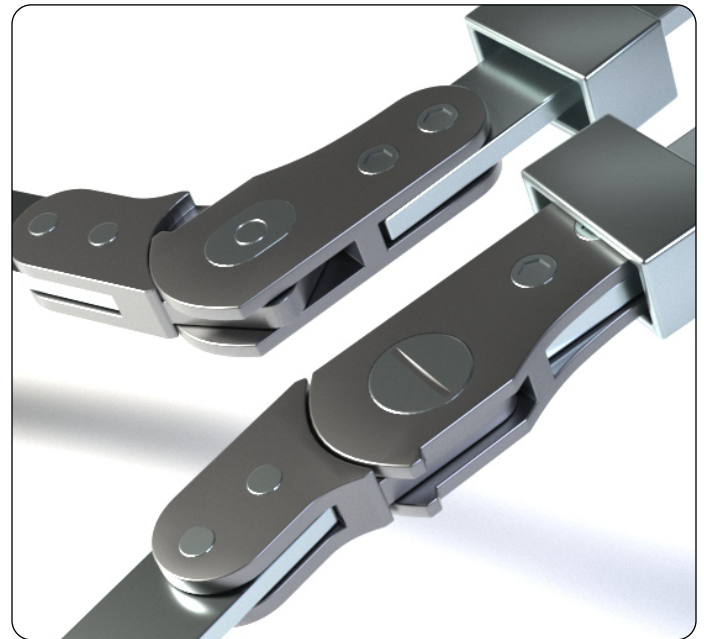
Lab inspection revealed that the lateral aluminum upright bar, in a purposefully bent portion immediately above the knee joint lock, had sustained a through-fracture with little overall deformation of the bar.

Optical microscopic and scanning electron microscopic examinations of the fracture surface revealed a region of transgranular fracture extending from the bar surface that was immediately adjacent to the knee. Surface residues were also present in this region and their analysis revealed the presence of various elements including sodium and chlorine. A region of fatigue striations was also observed extending from the transgranular area that transitioned into overload fracture.

It was concluded that the aluminum alloy bar failed due to stress corrosion cracking (SCC) initiating at its surface that transitioned to fatigue and eventual overload fracture. SCC is a metallic degradation phenomenon requiring a susceptible material, corrosive agent and tensile stress.

The fact that the cracking initiated adjacent to the woman's knee was telling. That and the detection of quantities of sodium and chlorine confirmed the ESi investigator's experience that chlorides were the aggressive corrosive agent. The source of the chlorides was human perspiration. Review of literature supported the fact that chloride induced SCC was an issue in external fixation device composed these same type aluminum alloys.
