Large Diameter (5-foot) Corrugated HDPE Pipe Failure Analysis

ESi performed a failure analysis of a large diameter (5-foot) corrugated HDPE pipe used in storm water management. Fractographic examination and material testing revealed the root-cause of failure was not related to extreme service conditions in Bahrain (Persian Gulf region) but caused by surface loading due to heavy machinery.

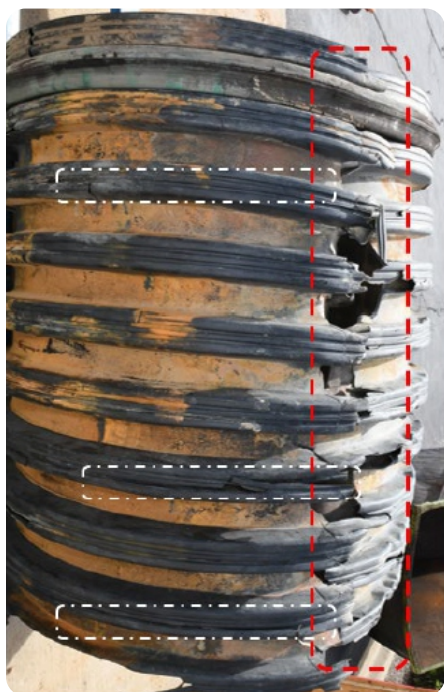
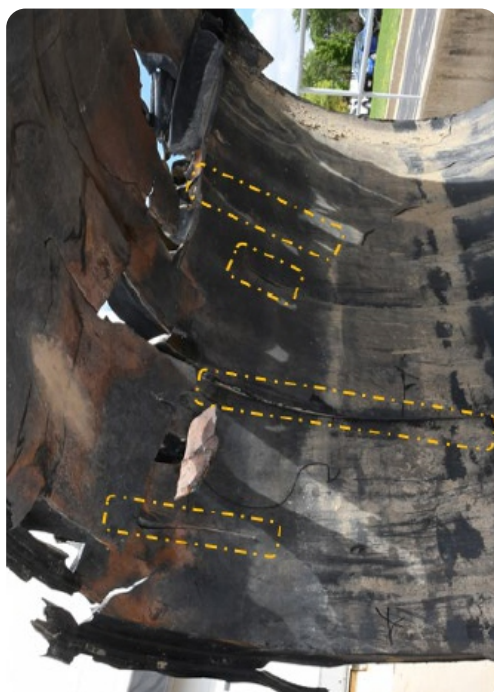
Fractographic analysis conducted using optical microscopes identified crack initiation points and crack propagation markings in both external corrugations and internal liner, allowing ESI to identify the fracture sequence through systematic analysis of the crack orientation and appearance. The analysis revealed the HDPE pipe had experienced buckling from compressive loading and failed due

to circumferential cracks developing in the corrugations. Our review of the installation documentation, quality control records, and design specifications with the client's project team revealed that construction activities caused heavy machinery to be parked over the pipeline location.

Material analysis confirmed that HDPE material degradation had not occurred in service, rather long-term mechanical loading induced circumferential cracking along the external corrugations. This shifted the structural loads to the thin-walled inner liner which in turn caused liner buckling and failure via slow crack growth mechanism with longitudinal cracking resulted from fast fracture.

Overview of circumferential through wall cracking in the corrugations and longitudinal through wall cracking in the inner liner component of the subject 60-inch HDPE stormwater pipe segments provided.

Our analysis enabled immediate remediation of road collapses and informed enhanced design considerations for future pipeline installations. The findings provided critical insights for double-wall corrugated pipe performance under construction loading, preventing similar failures throughout the facility and contributing valuable knowledge for petroleum industry infrastructure projects.
