## Failure Analysis of Spray Polyurethane Foam (SPF) Insulation

### The Situation

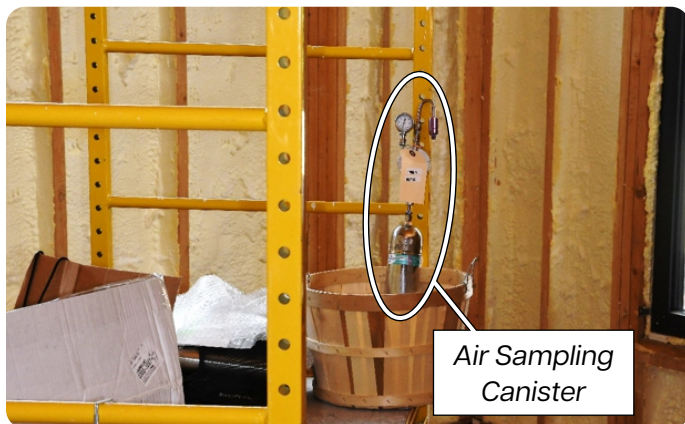
ESi also determined the foam density to compare to expected values, analyzed the foam pore structure via optical microscopy, and evaluated how well the foam had cured via differential scanning calorimetry (DSC) and Fourier transform infrared (FTIR) spectroscopy. The results of this suite of testing showed that the foam samples all exhibited characteristics typical for fully cured SPF insulation.

This, along with the foam emission testing, indicated that no evidence of improper installation could be found. Our team's report stressed the importance of finding a link between VOCs detected in the air that could be sources of odors and emissions from actual foam samples.
