CASE STUDY

BICYCLE RIDER PITCH-OVER ANALYSIS AND TESTING REFUTE OPPOSING HYPOTHESIS

Bicycle Forensics & Analysis

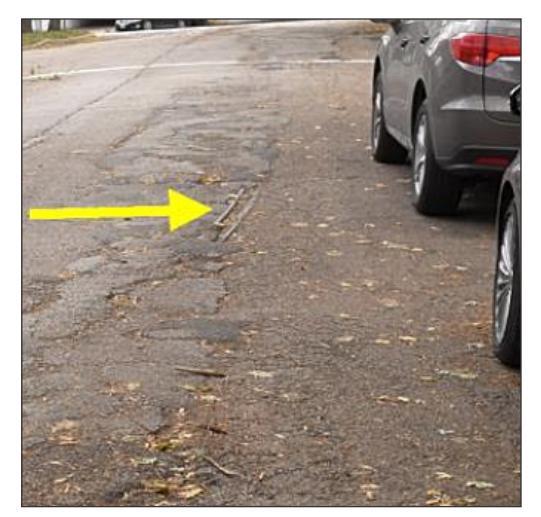
The opposing technical expert asserted a hypothesis that the bicycle interacted with a section of streetcar rail channel that had been paved over with asphalt but over time had become exposed due to the flow of the asphalt. The theory stated that the front wheel of the bicycle entered the channel and followed it to a location where it encountered a 1½" obstruction. The claim is that this obstruction arrested the forward motion of the front wheel and caused the bicycle and rider to pitch over. The technical expert never subjected the hypothesis to testing to see if it could be proved or disproved.

Rail Channel in Asphalt

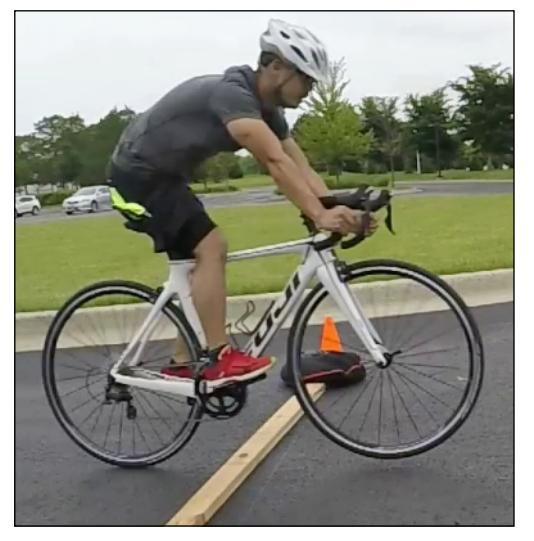
In evaluating the circumstances of the incident prior to testing, ESi recognized that the propensity for a bicycle to pitch over is related to the speed of the bicycle at the time that it engages the obstruction and the height of the obstruction. Unfortunately, the physical evidence available in this matter was insufficient to reconstruct the speed of the bicycle in the moments leading up to the incident. The rider stated that he was riding at a "moderate speed". ESi therefore, elected to conduct the testing of the hypothesis at a nominal speed of 15 mph. Since the dimensions of the obstruction could not be measured – the road had been resurfaced and thus were unknown, ESi used a step obstruction with a height of 1½" for the testing. Multiple passes of a rider on a road bike with no pitch-over events showed that the hypothesis needed to be rejected.

Rider Testing with Obstruction
