## PVC Plastic Threaded Fitting Failure Analysis

**Engineering analysis determined yacht sinking resulted from improper installation practices, not manufacturing defects.**

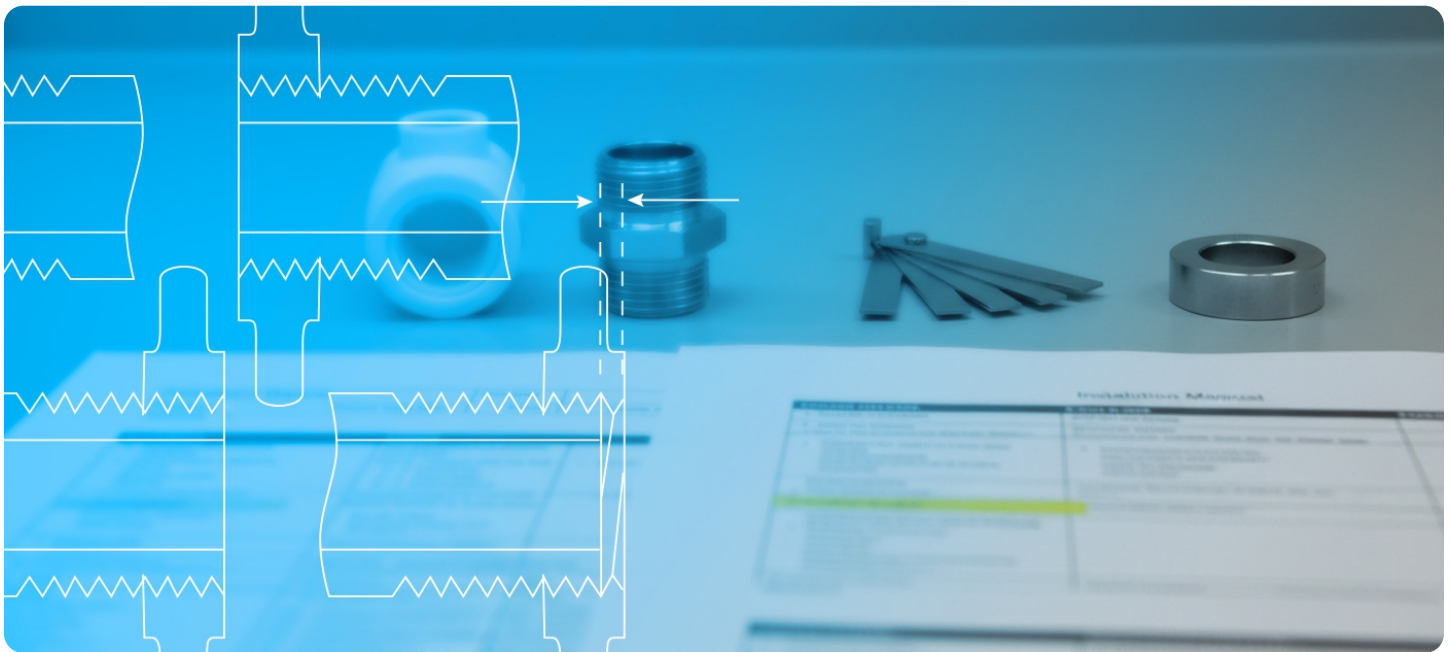
A 43-foot luxury yacht experienced partial sinking due to water intrusion caused by catastrophic failure of a PVC plastic threaded fitting in the live baitwell pump assembly. The PVC internally threaded fitting was connected to an externally (male) threaded metal fitting. The PVC fitting failed by a longitudinal crack that developed at the connection.

Fracture surface analysis revealed critical evidence of crack initiation patterns and propagation mechanisms that was consistent with time dependent creep-rupture failure mode, indicating sustained stress over time rather than sudden overload. ESI employed Energy Dispersive Spectroscopy (EDS) to determine elemental composition of the metal component while using Fourier Transform Infrared Spectroscopy (FTIR) to confirm the material identification of the plastic fitting and verify it met material specifications. ESI also performed stress analysis calculations to determine the hoop stress levels generated during installation and how they compared to the material's long-term strength capabilities.
