Large Diameter (5-foot) Corrugated HDPE Pipe Failure Analysis

ESi performed a failure analysis of a large diameter (5-foot) corrugated HDPE pipe used in storm water management. Fractographic examination and material testing revealed the root-cause of failure was not related to extreme service conditions in Bahrain (Persian Gulf region) but caused by surface loading due to heavy machinery.

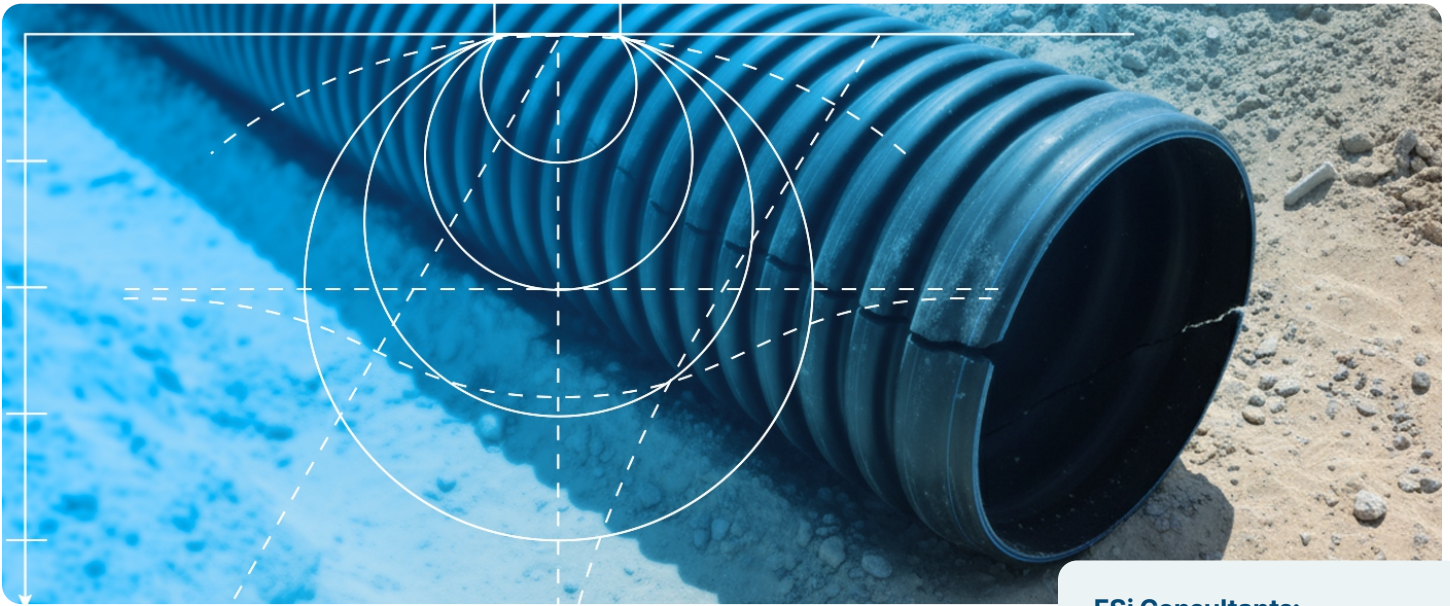
Fractographic analysis conducted using optical microscopes identified crack initiation points and crack propagation markings in both external corrugations and internal liner, allowing ESI to identify the fracture sequence through systematic analysis of the crack orientation and appearance. The analysis revealed the HDPE pipe had experienced buckling from compressive loading and failed due

to circumferential cracks developing in the corrugations. Our review of the installation documentation, quality control records, and design specifications with the client's project team revealed that construction activities caused heavy machinery to be parked over the pipeline location.

Material analysis confirmed that HDPE material degradation had not occurred in service, rather long-term mechanical loading induced circumferential cracking along the external corrugations. This shifted the structural loads to the thin-walled inner liner which in turn caused liner buckling and failure via slow crack growth mechanism with longitudinal cracking resulted from fast fracture.

Overview of circumferential through wall cracking in the corrugations and longitudinal through wall cracking in the inner liner component of the subject 60-inch HDPE stormwater pipe segments provided.

Our analysis enabled immediate remediation of road collapses and informed enhanced design considerations for future pipeline installations. The findings provided critical insights for double-wall corrugated pipe performance under construction loading, preventing similar failures throughout the facility and contributing valuable knowledge for petroleum industry infrastructure projects.
