## Chemical Compatibility Assessment of CPVC Fire Suppression Sprinkler Pipe

ESi investigated CPVC fire sprinkler pipe compatibility with common plasticizers chemicals found in communication wires and cables.

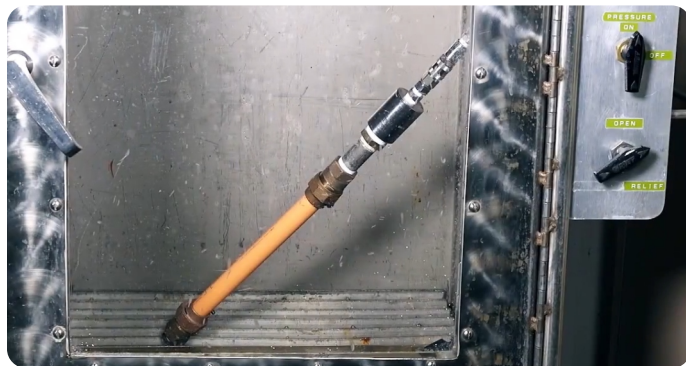
ESi's testing demonstrated that CPVC pipes exposed to pure plasticizers at service pressure (175 psi) for over 5,400 hours showed no reduction in burst strength compared to control samples, with failure occurring away from chemical application areas. While pipes tested at elevated pressures (670 psi) with wire contact did show some strength reduc-

tion, they still exceeded ASTM requirements by significant margins. All tested pipe assemblies demonstrated burst strengths significantly exceeding ASTM D1599 requirements. Notably, ongoing sustained pressure testing at 175 psi with Cat5e and fire alarm cables reached 7,800 hours as of August 2025 and continued without signs of cracking or pressure loss. Our findings revealed that chemical incompatibility is both time and stress dependent - at normal service pressures, the stress levels are below the critical threshold required for ESC to occur.

The testing protocol included long-term sustained pressure testing at both service pressure (175 psi) and elevated test pressure (670 psi) for durations exceeding 1,000 hours, with one assembly tested for 5,472 hours (228 days). Following sustained pressure exposure, we conducted hydrostatic burst strength testing per ASTM D1599 to evaluate any degradation in pipe integrity. We used digital stereomicroscopy to examine pipe surfaces for stress cracking and analyzed fracture surfaces to understand failure modes. Our approach incorporated stress-rupture curve analysis to determine critical stress levels required for chemical incompatibility to manifest.

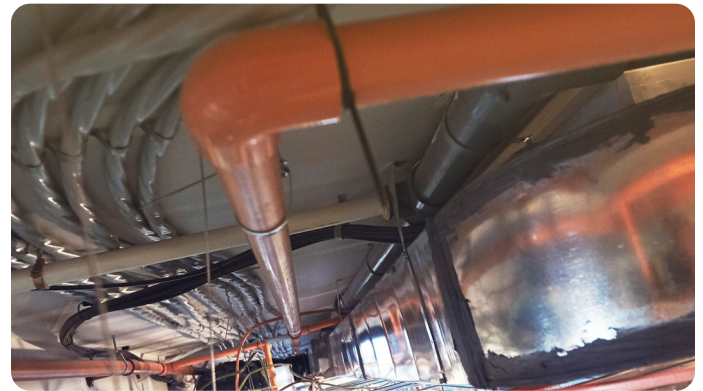
Photo (above) taken from Lubrizol white paper by Liotta, L (2019) "Not all wiring systems are the same – Learn what is compatible with BlazeMaster® CPVC"; Photo (left) taken from video: BlazeMaster® CPVC vs. Spears FlameGuard®, [www.blazemaster.com](http://www.blazemaster.com)
